# Safety Recall

## Chaperone Infant Car Seats

**Manufacturing Dates: Between September 1, 2010 and April 30, 2011**

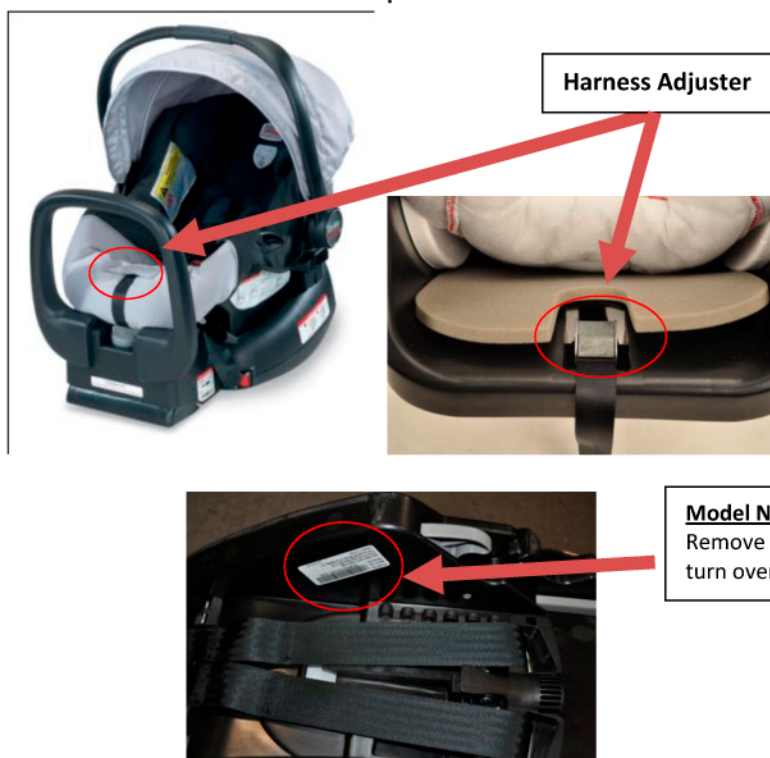
The harness adjuster ensures that the harness straps can be properly tightened and secured over the infant shoulders and is attached to the infant car seat shell. The rivet used to attach the harness adjuster to the shell may have been improperly installed. As a result, the harness adjuster may detach from the shell. Should the harness adjuster detach from the infant car seat shell the harness straps will not properly secure the child resulting in increased risk of injury in a vehicle crash.

If the harness adjuster on your Chaperone Infant Car Seat detaches, please discontinue use of the product immediately and contact our Customer Service Department at 1-888-427-4829.

Contact Britax Child Safety, Inc. to receive free harness adjuster clip kit at:
